Plant Service Bulletin

Spray Attemperators for Industrial Boilers

This plant service bulletin (PSB) advises owners and operators of known superheater attemperator problems and provides recommendations for corrective action.

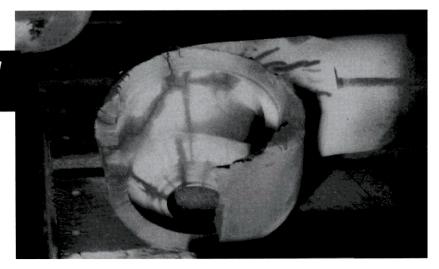
Figure 4 Failed attemperator spray head.

If small parts of the attemperator system break off and are carried downstream, tube plugging may occur and cause localized tube overheating. Larger parts of the spray head also can break loose (Figure 4) and get lodged in the venturi. If this occurs, steam flow is blocked, causing increased pressure drop and uncontrolled steam temperatures. Steam leakage also can result from cracks that have developed in the attemperator body and propagated through the wall.

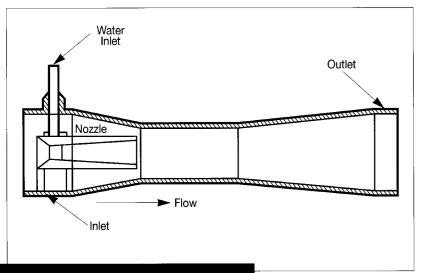
Figure 6 The Graham attemperator design does not have a liner.

Attemperator Body –
including cracks and erosion,
especially when there is not a
liner (reference Figure 6)

All attemperators with liners should be visually inspected after 10 years of operation. Those without a liner, however, should be inspected after five years of service (Figure 6). Future inspections for all attemperators should be on five-year intervals unless damage is found.

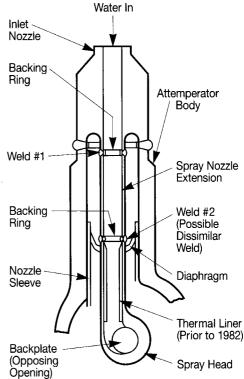
Figure 7 B&W spray nozzle assembly.

- Spray Nozzle Assembly (Figure 7) – including the diaphragm, welds on the nozzle extensions (weld #1 and #2), backplate, and the inside and outside of the spray head
- Attemperator Liner, if one exists (Figure 8) including the liner welds (circumferential
