Floor Tube Corrosion: External and Water Side

Purpose

Advise owners and operators to inspect specific areas of the floor of Kraft recovery boilers for external corrosion on the underside of the tubes and stress-assisted corrosion on the water side of the tubes.

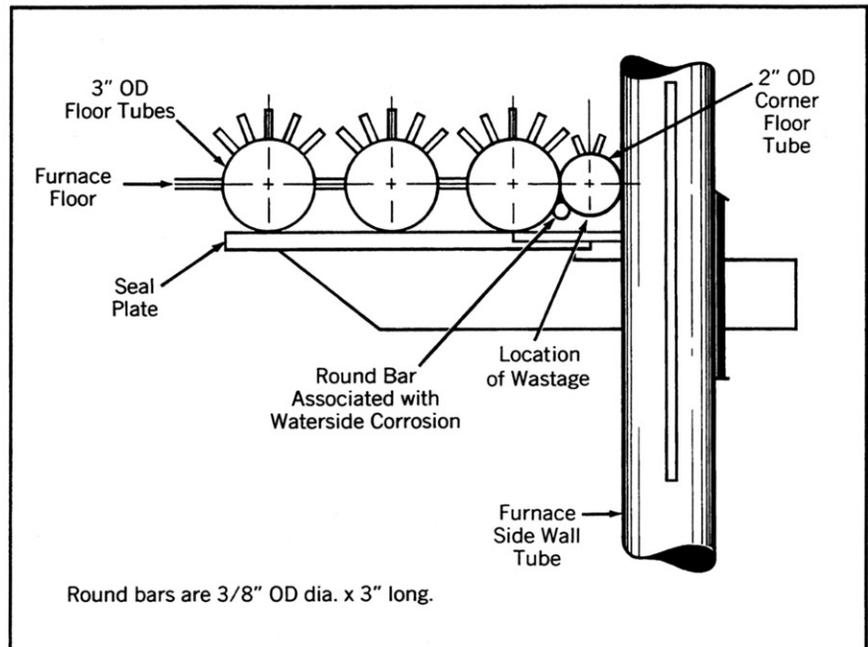
Recent inspections have revealed two independent forms of corrosion in the floor tubes of boilers that are equipped with the smelt spouts on the rear wall and that utilize a 2" OD floor tube construction adjacent to the sidewalls. This 1970's vintage construction, which can exist in either one of two arrangements, is shown in Figures 1 and 2. The corrosion problems may occur in either arrangement.

Figure 1. Example of 3/8" round bar welded on one side of the corner floor tube only and spaced on two foot centers.

- During the next scheduled outage, inspect the underside of the 2" OD corner floor tube and adjacent 3" OD floor tube for external corrosion thinning. This may be accomplished by removing portions of the corner seal plates (as shown in Figure 1 and 2) from the underside of the furnace floor and measuring the tube thickness.
- During the next scheduled outage, inspect the water side (ID) of both the 2" OD corner floor tube and adjacent 3" OD floor tube for evidence of water side stress-assisted corrosion and cracking associated with the 3/8" diameter alignment bars.

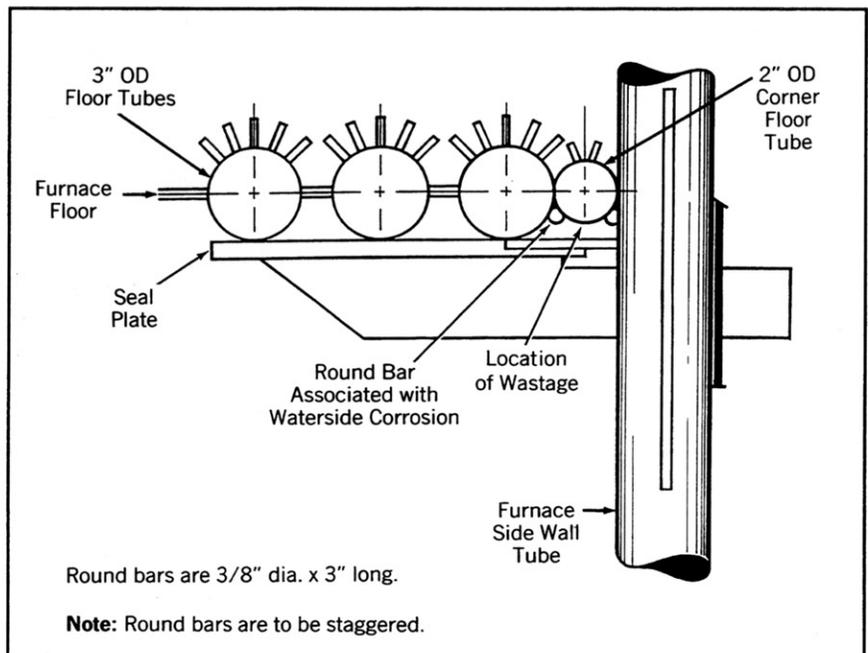
Figure 2. Example of 3/8" round bar welded to two sides of the corner floor tube and staggered on six foot centers.

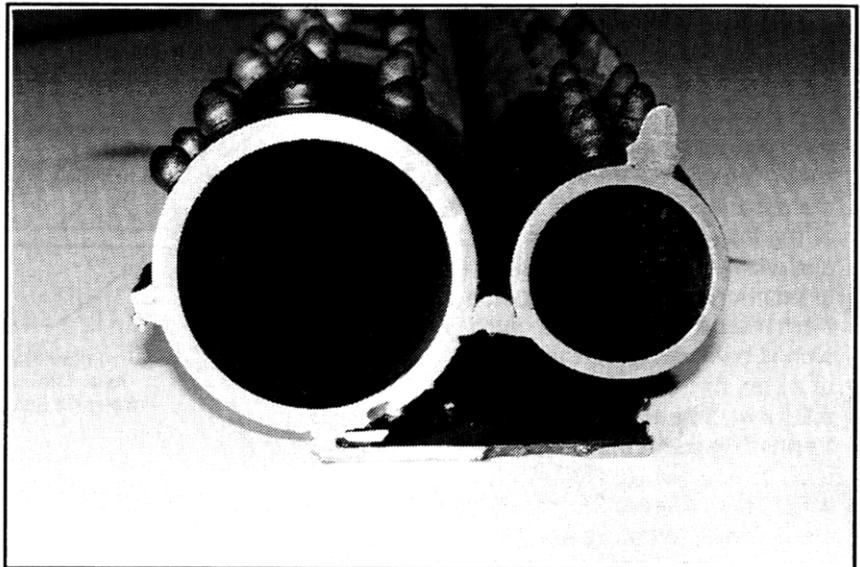
Figure 3.

cracking on the water side (ID) has also been reported in both the 2" OD floor tube and adjacent 3" OD floor tube. The corrosion tends to concentrate on the water side in the area immediately beneath the 3" OD floor tube. The corrosion tends to concentrate on the water side in the area immediately beneath the 3" long, 3/8" diameter round bars that are used for alignment as shown in Figures 1 and 2. The corrosion is believed to be caused by a less than ideal aqueous environment, with damage occurring at preferential sites due to the simultaneous action of stress and chemical reactions (Figures 4 and 5). There has been one verified failure of a 2" OD floor tube as a result of stress assisted corrosion located at a round bar attachment. Further information about stress-assisted corrosion and the locations where damage may prevail in recovery boilers can be found in Plant Service Bulletin #29, "Stress-Assisted Corrosion: Boiler Waterside", that was issued by B&W in November 1987.

Because this location does not lend itself to detection by radiography, an internal boroscope inspection may be the only feasible method.

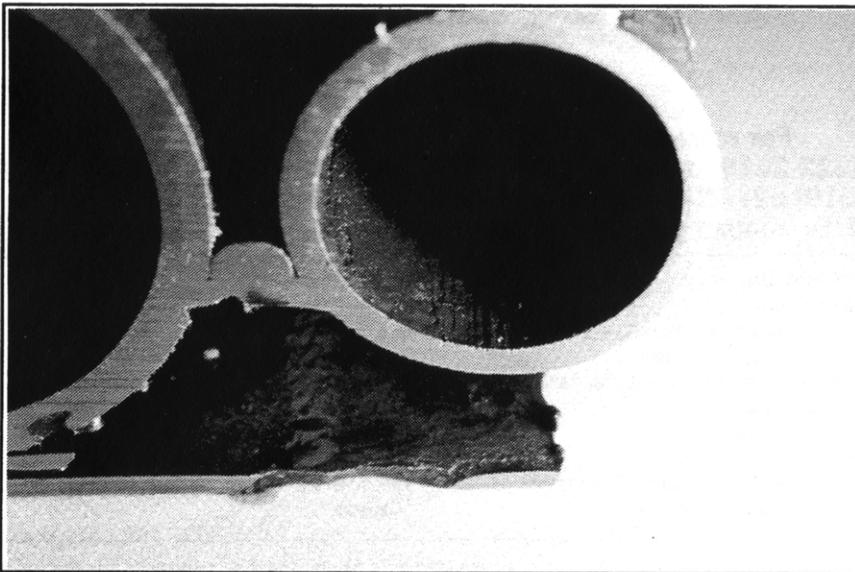
Stress-assisted corrosion on the water side of the 2" OD floor

tube can also occur on the crown of the tube on the cold side as shown in Figure 5. This condition can occur if the round bars on both side of the 2" OD tube were incorrectly installed in an opposing rather than in a staggered fashion. The issue of incorrect placement of round bars was addressed in Product Informative #9-1404 "Recovery Furnace Floor Improvements" that was issued by B&W in April 1983.

- If significant corrosion is found on either the OD or ID of the tubes, both the 2" OD and adjacent 3" OD floor tubes should be replaced.
- Replace both the 2" OD and adjacent 3" OD floor tubes if prior x-ray inspections have revealed the presence of sig-
