Riser and Tube Attachment Fatigue and Corrosion: Location and Evaluation Experience

Technical Service Bulletin

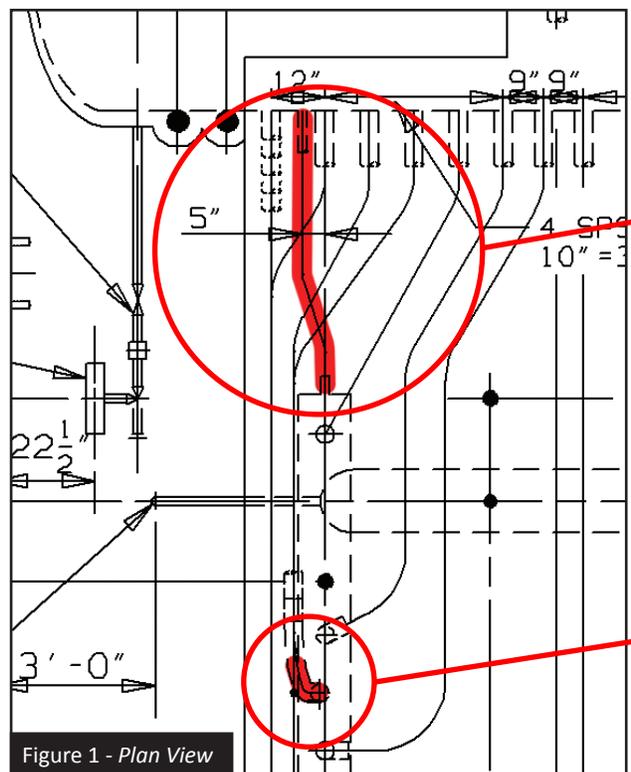
Figure 1 - Plan View

The sidewall outlet header nearest the steam drum has a small, 2 in. diameter relief riser off the end of the header which runs horizontally to the steam drum. The purpose of this connection is to ensure circulation flow in that circuit during transient (startup and shutdown) conditions, recognizing that relatively less heat input to that panel is observed because it passes alongside the nose arch. See Figure 1 plan view, Item 1.

are routed to the steam drum within the penthouse above any screen or superheater headers. A few of the risers bend out of the outlet headers and travel to the steam drum just outside the penthouse enclosure and enter the ends of the steam drum. See Figure 1, Item 2. Other risers are routed inside the penthouse but bend toward the drum within a short distance of the outlet header. See Figure 2 side view, Item 3.

All of these areas can develop stress-assisted corrosion due to waterside conditions combined with cumulative fatigue cycles.

3. During the next scheduled outage, perform radiographic testing of riser bends, relief risers and attachment weld locations in the penthouse.
4. Visually inspect any tubing removed from the suspected locations for damage.
