Riser and Tube Attachment Fatigue and Corrosion: Location and Evaluation Experience

Technical Service Bulletin

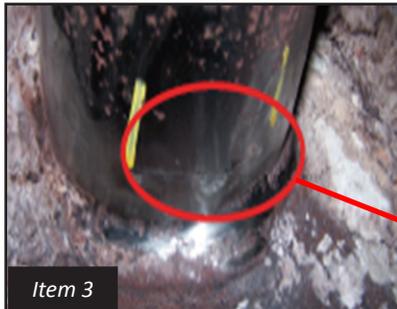
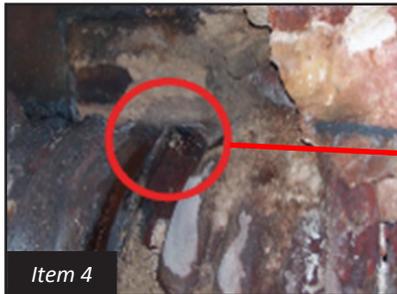
Experience has shown that the various riser tubing and attachment locations are areas that may develop stress-assisted corrosion or fatigue damage after many years of operation. The waterside environment combined with the stress concentrations related to flexibility and discontinuities, such as bends and attachments, are reasons why this cracking can develop over time.

To date, radiographic testing is the only proven non-destructive technique that provides positive detection of corrosion damage. Other non-destructive examination methods are under investigation for characterizing the extent and depth of corrosion damage.

3. During the next scheduled outage, perform radiographic testing of riser bends, relief risers and attachment weld locations in the penthouse.
4. Visually inspect any tubing removed from the suspected locations for damage.
